OUTLINE REPORT OF
ARCHITECTURAL WORK
ON THE RESTORATION OF THE
CHESAPEAKE AND OHIO CANAL
FOR RECREATIONAL USE
(GEORGETOWN, D. C., TO SENECA, MD)

BRANCH OF PLANS AND DESIGN
Thos. C. Vint
Chief of Planning

1939

Dallas D. L. McGrew
Associate Architect

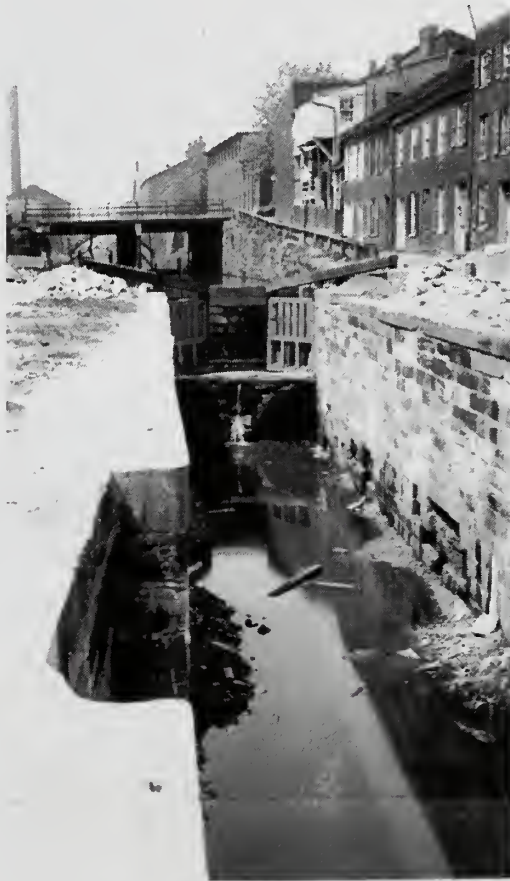
Photograph 1: Swing Gates. Lock No. 4, in Georgetown, shows also the character of the Lock masonry and the dam at head of the Lock. Composed of heavy planks lowered into slots cut in the stone. This served to hold back water during repairs. The curve of the arch of the Wisconsin Avenue Bridge appears in the background.

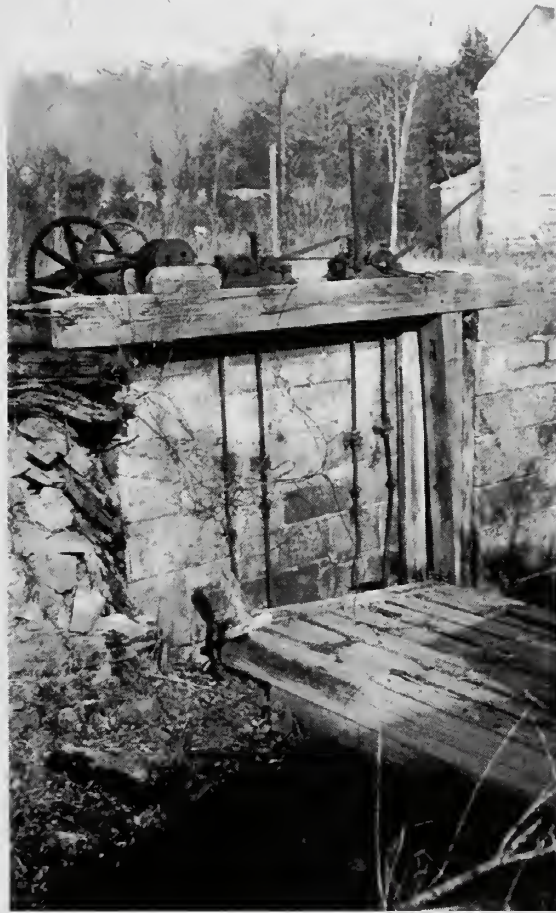
Photograph 2: Drop gate and machinery at Lock No. 12. Gate in open position.

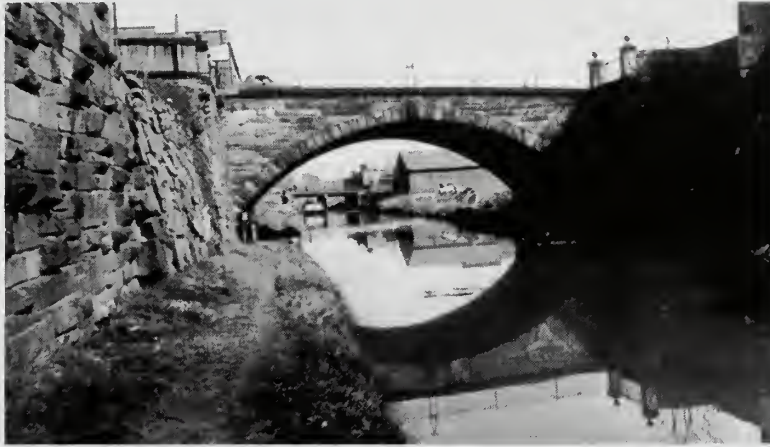
BRIDGES: In passing through Georgetown, the Canal was spanned by a series of stone arch bridges of which only that carrying Wisconsin Avenue survives. This handsome structure, completed in 1831, is in excellent condition. An inscription on its east face records the fact that Andrew Jackson was President at the time. In its northwest corner stands a marble obelisk to mark the completion of the Canal to Cumberland in 1850.

Photograph 4: Wisconsin Avenue Bridge, looking east along towpath.

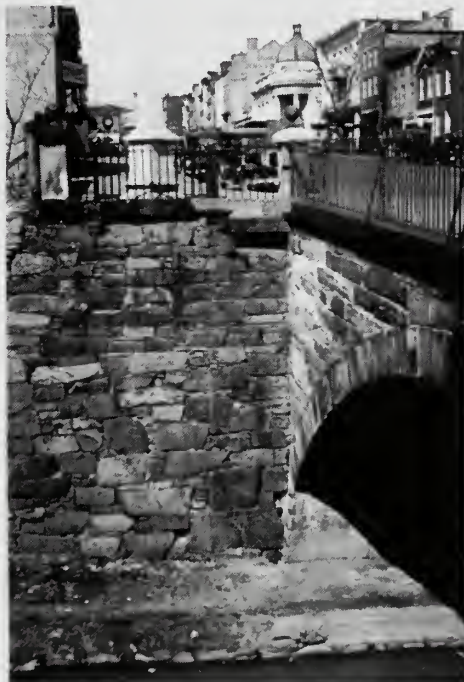
Photograph 5: Northwest corner of Wisconsin Avenue Bridge. Note character of masonry of bridge and retaining wall, the sturdy wrought iron fence, and the memorial obelisk.

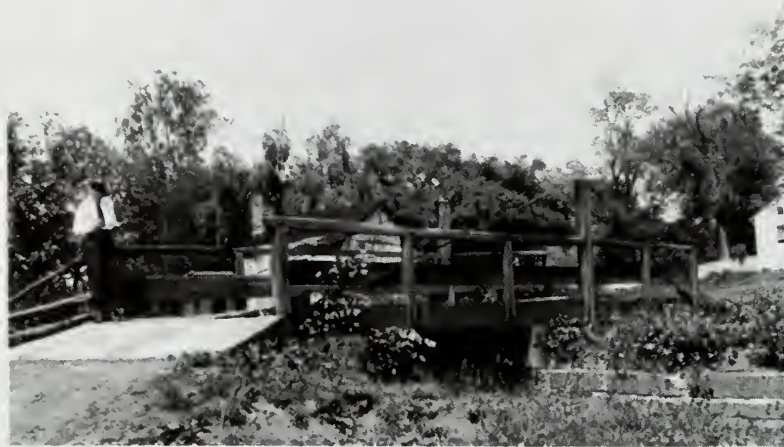
Photograph 6: Swinging Wagon Bridge at Lock No. 25 (Edwards' Ferry). This type of bridge is being used wherever vehicular passage across the Locks is needed.

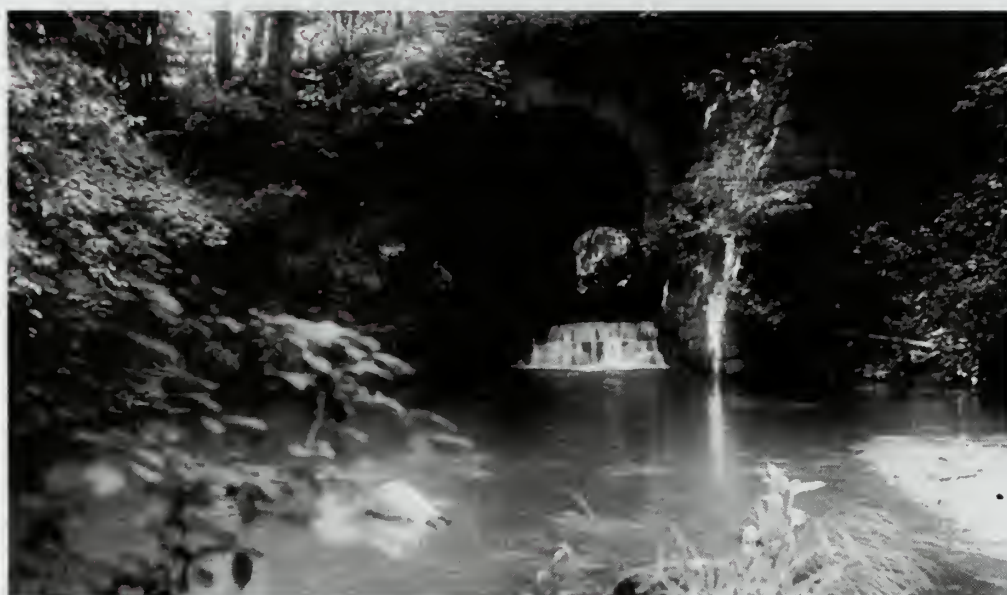
Photograph 13: Rock Run Culvert, below Lock No. 11. An excellent example of the substantial character and simple design of the canal masonry.

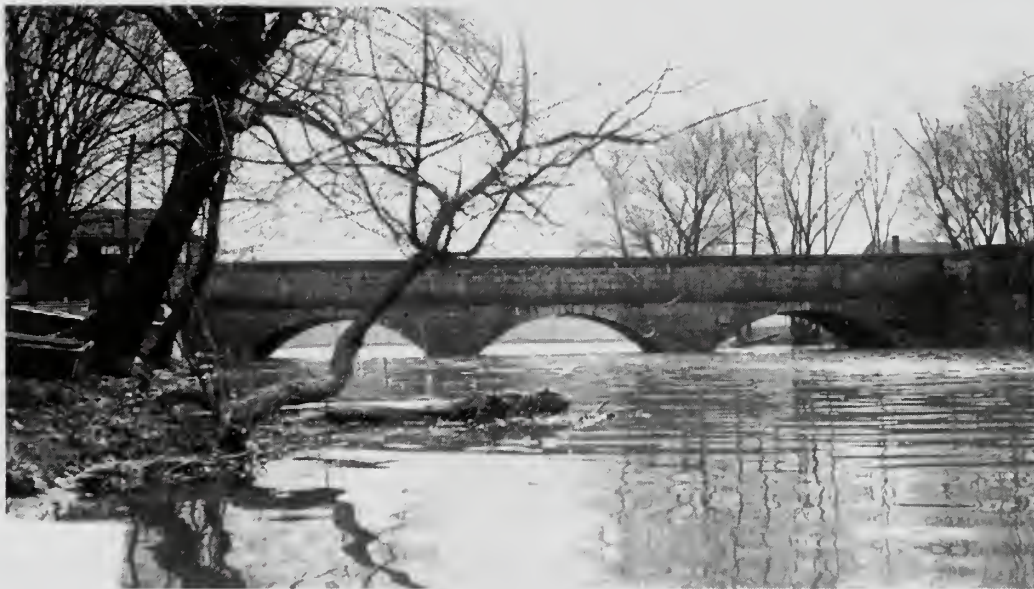
AQUEDUCT: Although it is outside the scope of the present project, an aqueduct crosses Seneca Creek at Lock No. 24. This is illustrated here because it is a substantial and handsome structure of three segmental arches and abutments built of cut Seneca sandstone. It is in fair condition and can be used without repairs.

Photograph 15: Seneca Aqueduct, looking from Seneca Creek toward the Potomac. Although this is beyond the present restoration project, it is easily accessible from Lock No 23 and is so handsome and sturdy a structure, typical of such work throughout the length of the canal, that it is illustrated here.

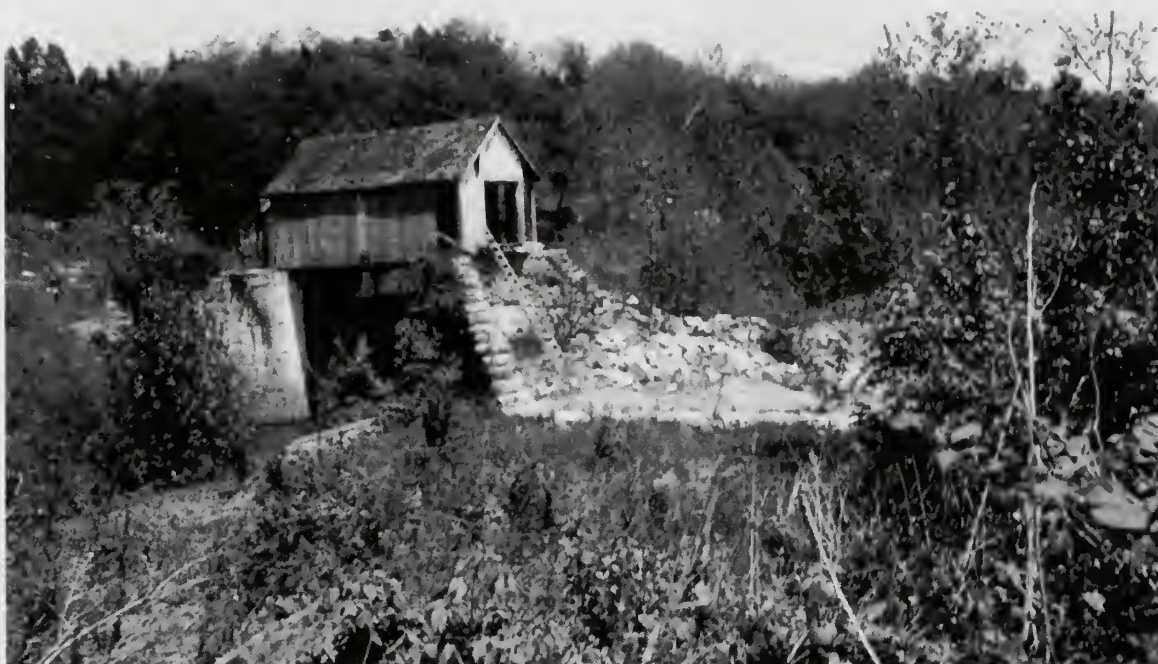
Photograph 21: Stop Lock and building at Dam No. 4 below Williamsport, Maryland. It is reported that in the great flood of 1936, that destroyed this section of the dam, this little building was submerged to within eighteen inches of its ridge and survived. The girders forming the temporary dam between the stop lock abutments can be seen in place, below the building.

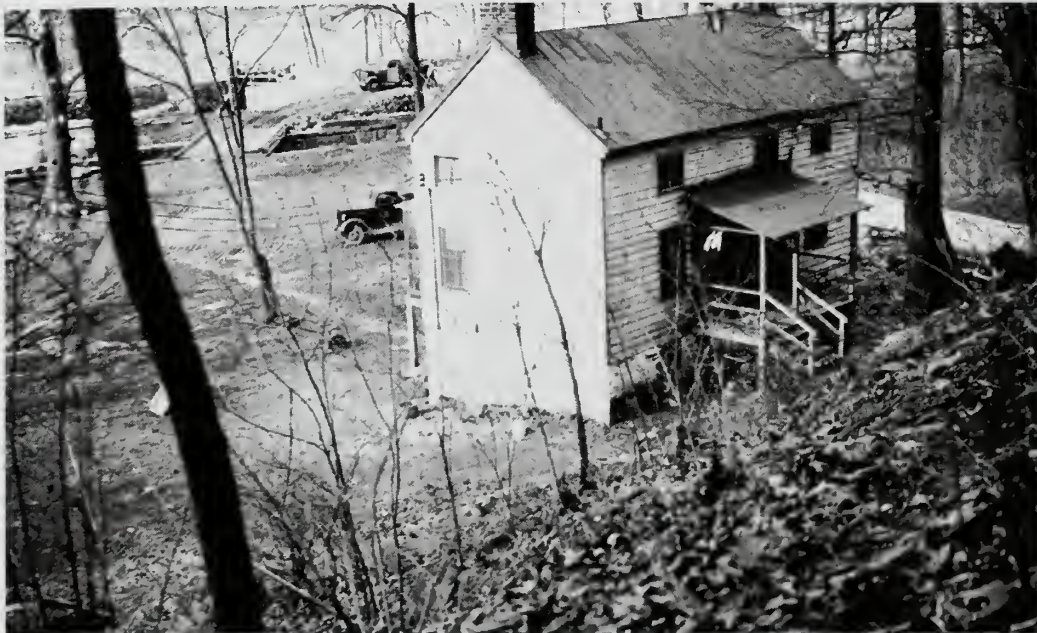
Photograph 25: Another view of this house from the hillside behind it. Beyond the house is the canal lock crossed by a bridge leading to the towpath. This will be replaced by a swing bridge. Beyond again is the gate controlling the water entering the canal from the Feeder canal, and in the background the Potomac River can be seen.

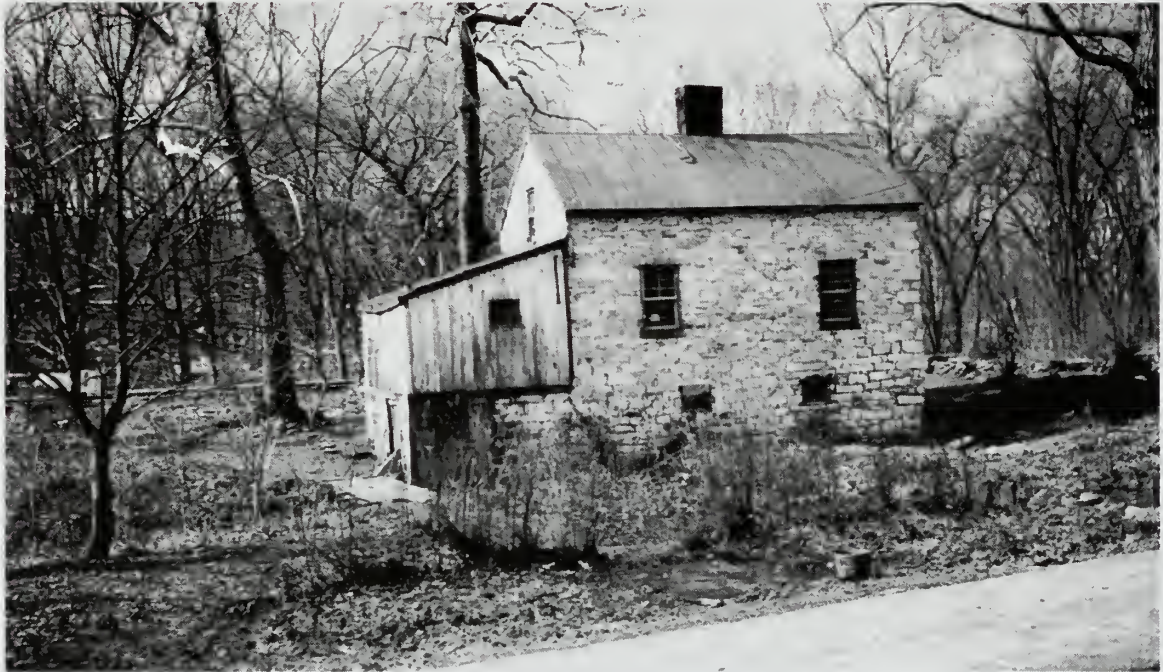
At Lock No. 6 is the first of the typical stone houses built from the specifications laid down by the Canal directorate in 1828. It is interesting to note that these houses were expected to cost, under contract, about \$700 each, and most of them were completed at about that figure. The records show that this house, built in 1848, was the second on this site, the first one having been so seriously damaged by flood in October 1847, that it was considered cheaper to build anew than to repair. Here, as elsewhere, slight individual variations from type appear, caused by small differences in conditions. In this case variation is in the projecting side walls at the south end to form the foundations for a wooden kitchen. This building is sound and in usable condition.

Photograph 28: House at Lock No. 6 has kitchen built partly on projecting stone walls. The line of the lock appears in the background. This photograph shows excellently the texture of the old masonry as well as the adaptation of the specified type to differing conditions of site.

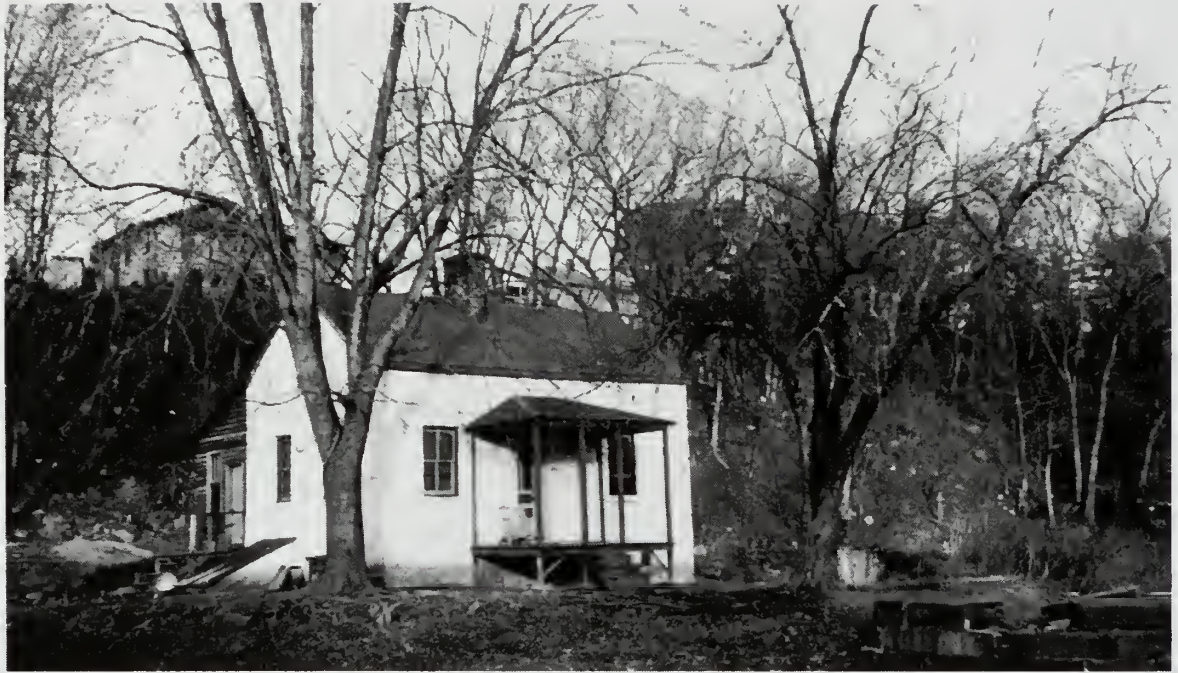
At Lock No. 8 is another stone house of the usual type, still usable in the condition to which it was brought by the repairs authorized in 1868.

Photograph 31: House at Lock No. 8. Lock wall in foreground at right. The walls of all the houses are to be whitewashed as in this case. In most instances the lock houses are flanked by a pair of fine trees, here maples.

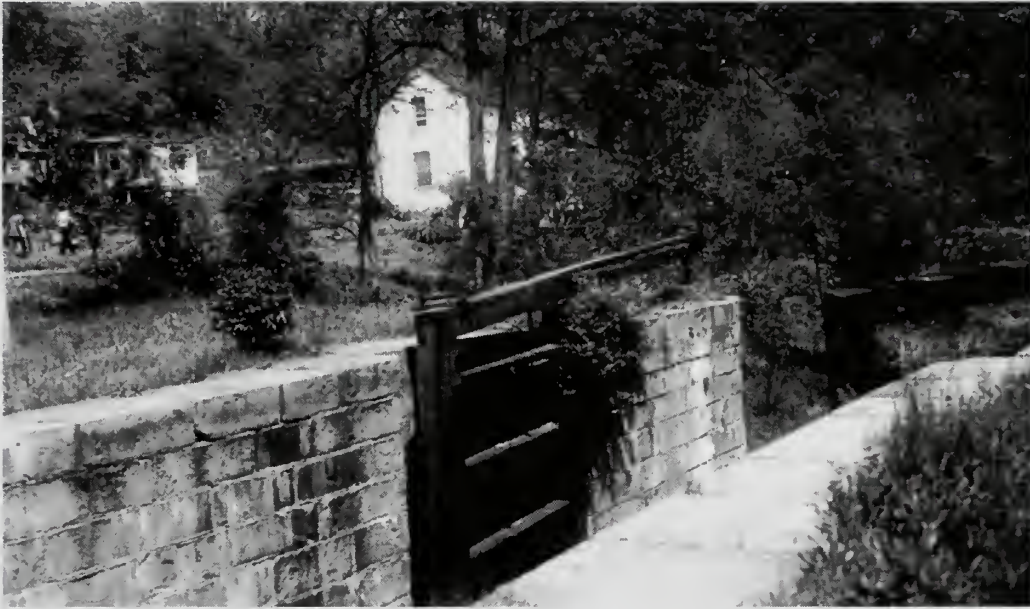
Another of the old stone houses stands at Lock No. 10. It is on higher ground a short distance from the Canal; was first occupied in 1830, and is in good condition. This is the third lock house selected for restoration and the problem is much the same as that of the house at Lock No. 7. On doors remaining in this house were found some of the original items of hardware, which have been reproduced to equip the other houses.

Photograph 33: House at Lock No. 10. The house is on higher ground and at a greater distance than usual from the lock; lock and gate in foreground.

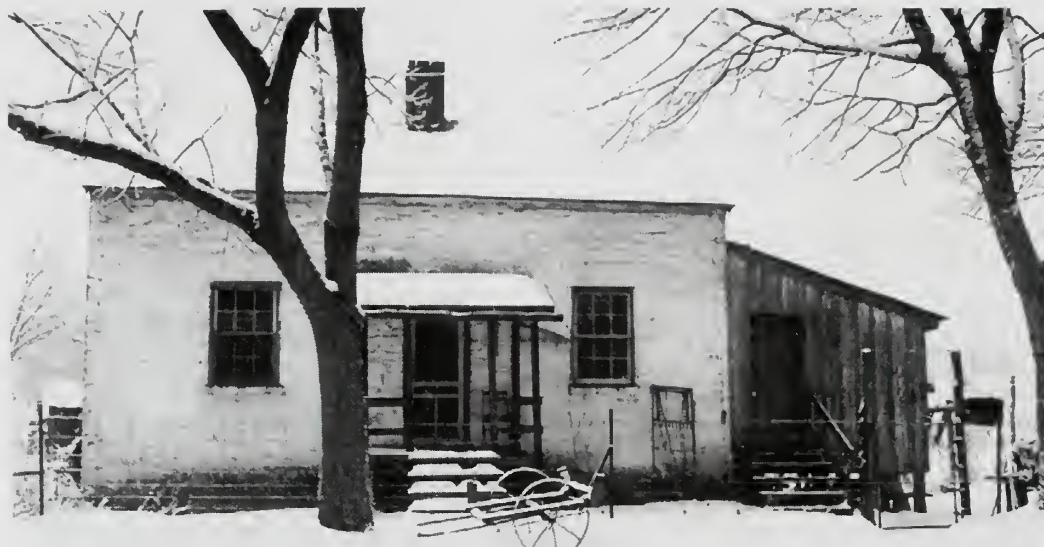
Lock No. 11 has another of the typical stone houses to which nothing is being done.

Photograph 35: House at Lock No. 11. This house on the towpath side has a small shed addition; it is in fair condition, and will continue in use as it is.

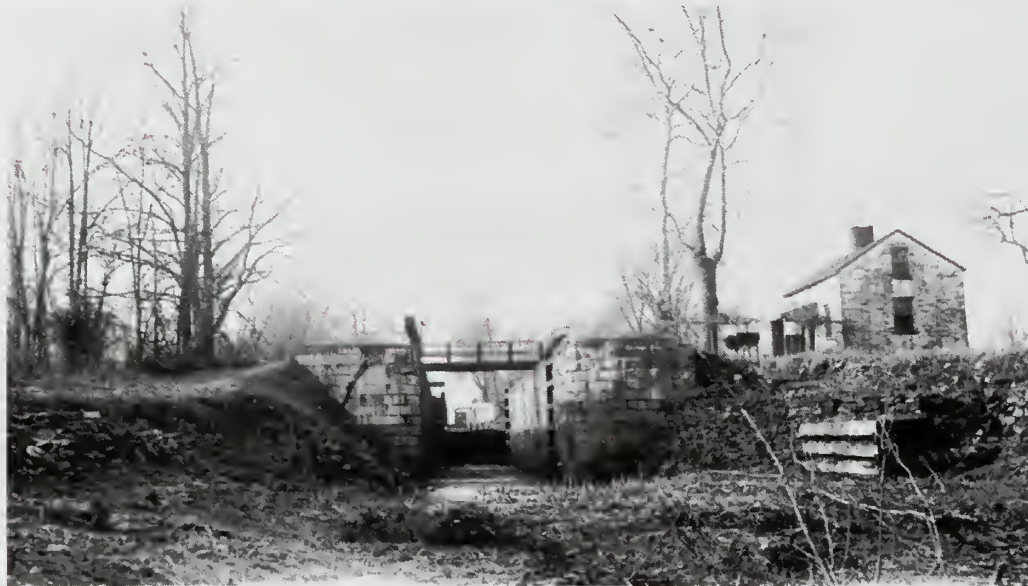
At Lock No. 13 stands another typical stone house, in fair condition. No work has been done.

Photograph 37: House at Lock No. 13 shown in relation to the Lock. As both gates are open, Lock No. 14 can be seen in the background. The house is in usable condition and continues to serve.

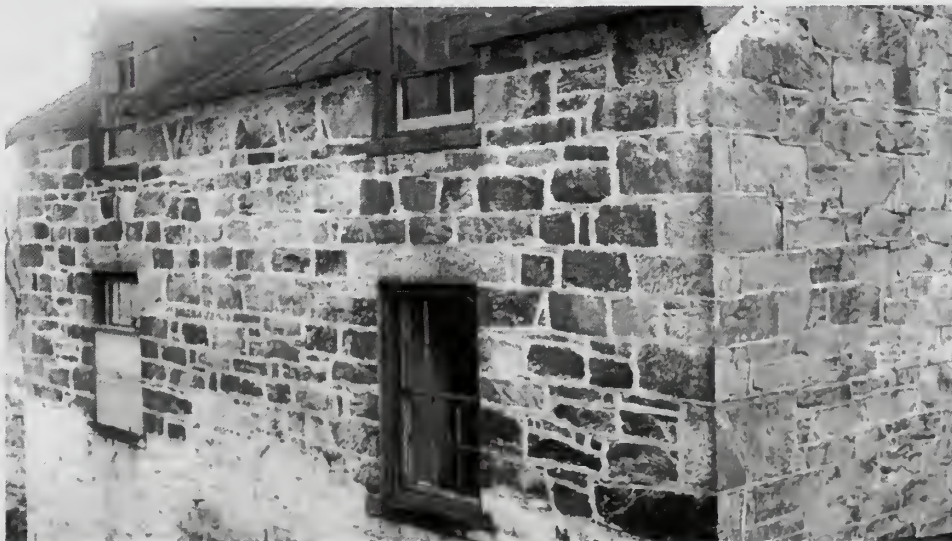
On a rocky ledge overhanging Lock No. 16 is a stone house having two stories and an attic with dormers, and a chimney at each end. This was built from a second specification, adopted in 1836. The building is in sound condition, being out of reach of all but the highest floods, but considerable work would be required to render it habitable.

Photograph 40: The substantial character of the masonry is clearly seen in this picture, as well as the type of dormer windows.

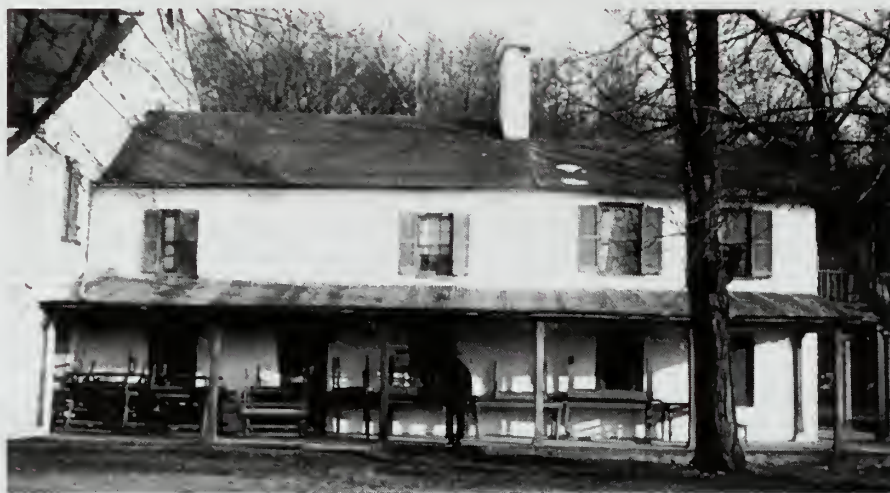
Photograph 43: The Great Falls Tavern. The central portion, from the chimney to the higher wall, was begun in 1828 as a lock tender's house, and is of the typical stone construction.

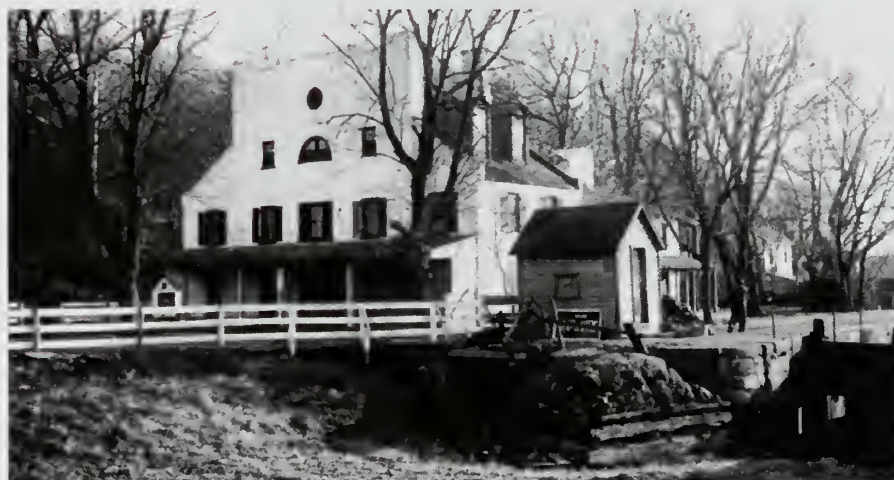
Photograph 44: The north front of the Tavern, completed in 1832, and built of brick, like the addition at the south end, completed at the same time. The porch is a comparatively recent addition and is to be removed. In the right foreground are the Lock (No. 20), gate closed, butterfly valve open, one of the slots for temporary dam, the cribbing between the lock and the opening for the spillway, and the much newer shack for the lock tender.

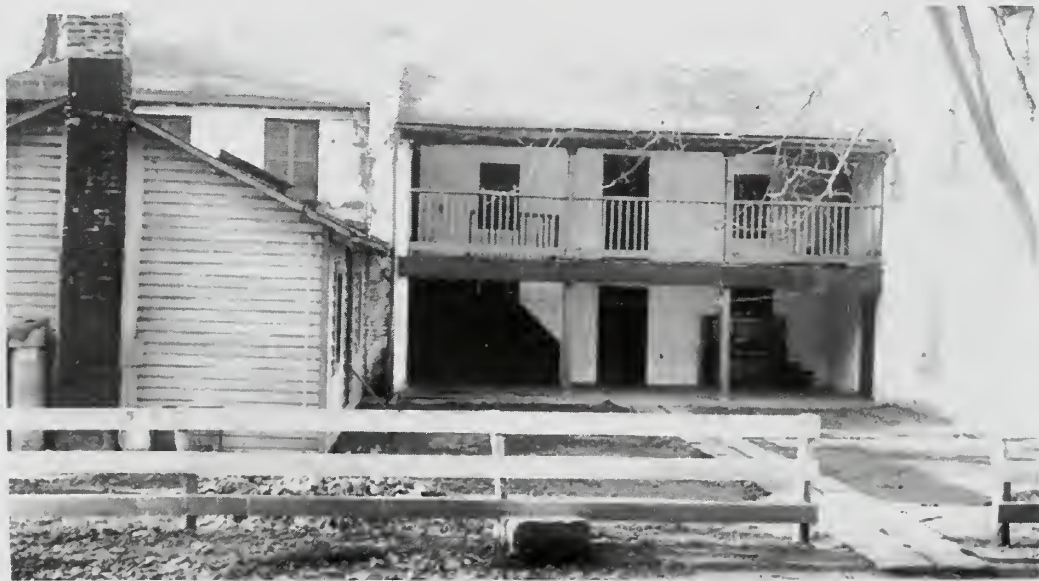
Photograph 46: The north side of the Tavern. On the left is the wooden kitchen added in 1926 to replace a similar structure. In the verandah or gallery, appears the slope of the outside stair that was the only means of communication between the ground and first floors. The central part is the 1828 building.

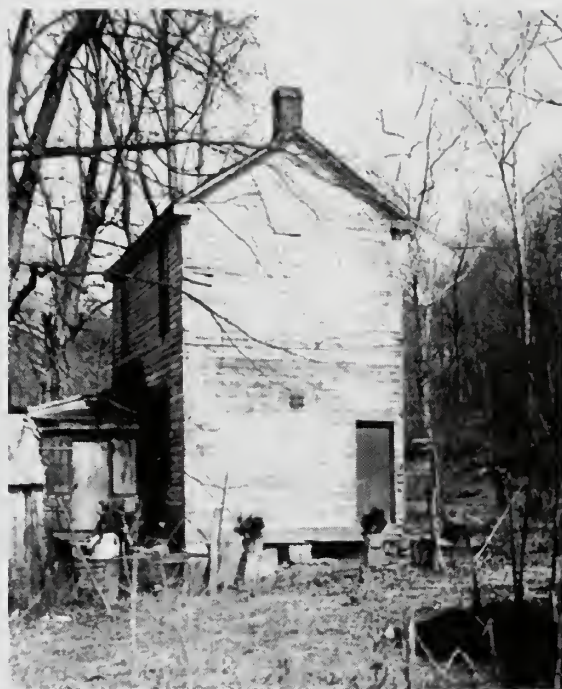
Also in this group are two frame houses erected at the same time as the log house, but of no importance, either historically or economically, to the Canal. It is proposed to raze both and to use the salvaged material wherever possible on other buildings.

Photograph 49: Frame House No. 1 at Great Falls. This will probably be demolished.

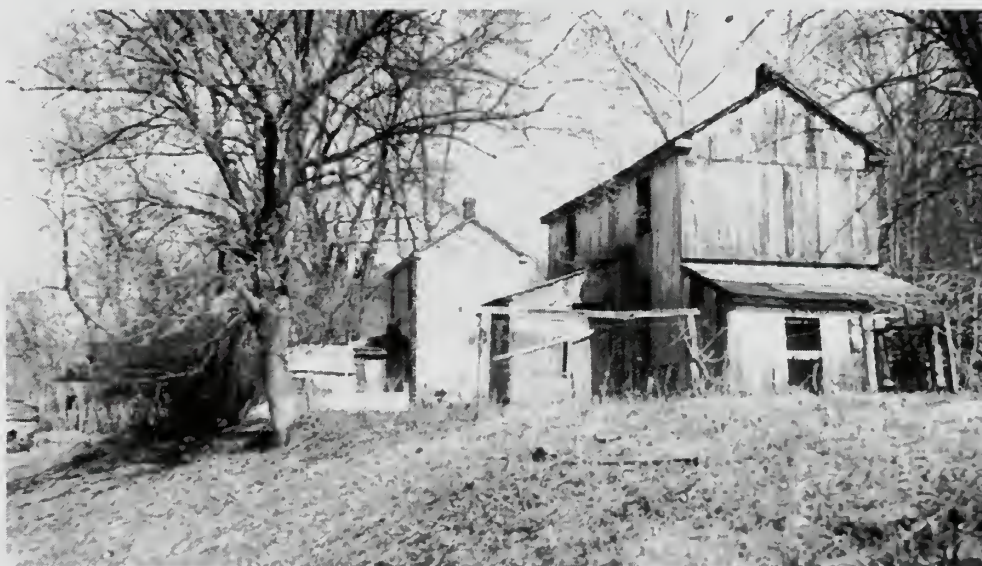
Photograph 50: Frame House No. 2 at Great Falls, from the Canal bank. Some of the material in these buildings will be salvaged for use. The siding from this house will probably be used on the structure at the stop lock above Lock No. 16.

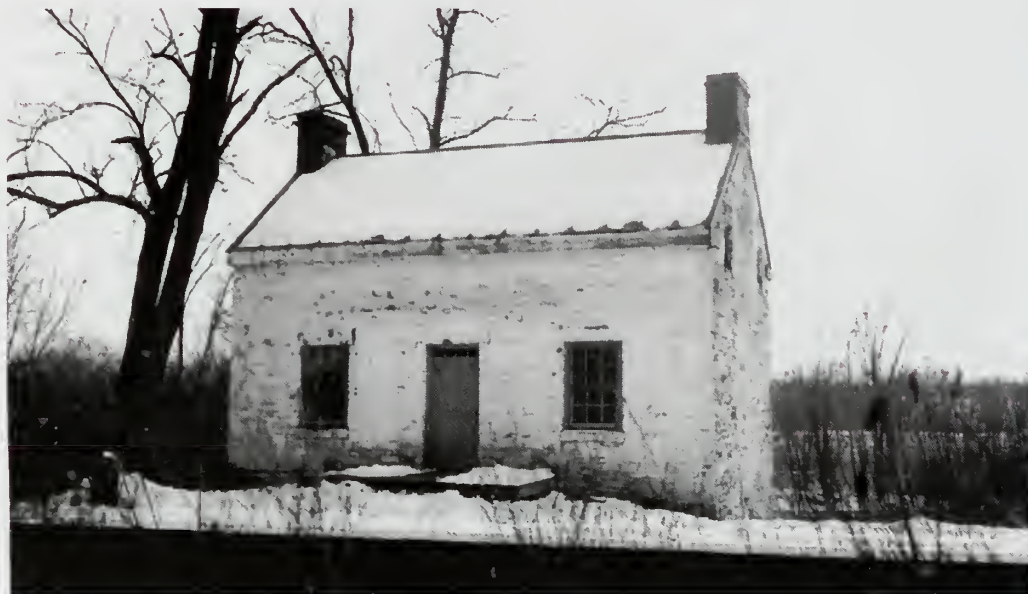
Lock No. 22 has a house of the type built from the 1836 specification, in good condition and needing little or no repair work.

Photograph 53: House at Lock No. 22, with Lock wall in foreground. These chimneys vary from type in being built of cut Seneca sandstone instead of brick. The trees here are black walnut.

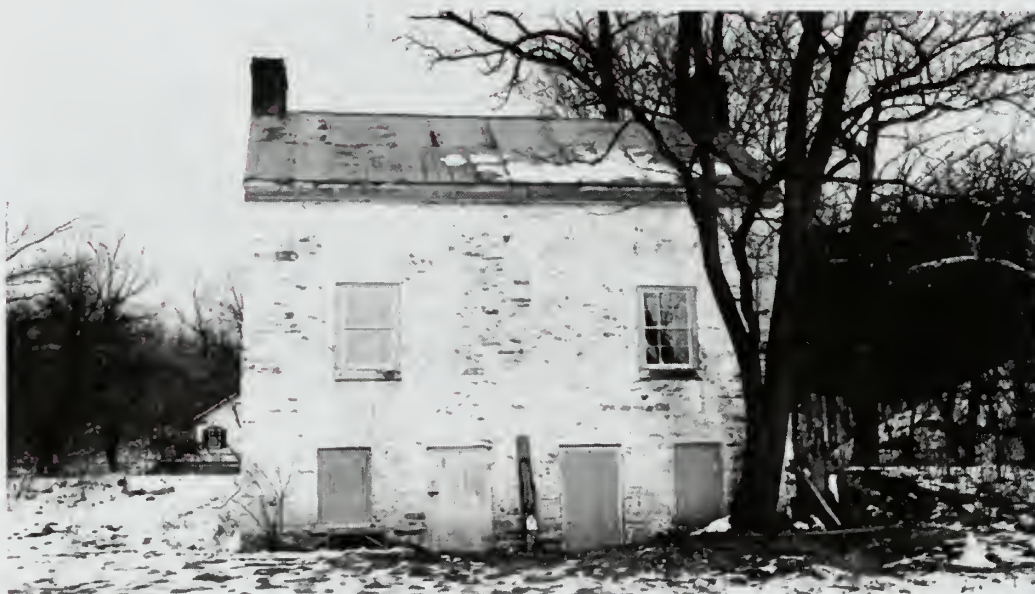
Photograph 54: Standing on sloping ground the house has another full story at the rear. This building is in good condition and can be used as is.

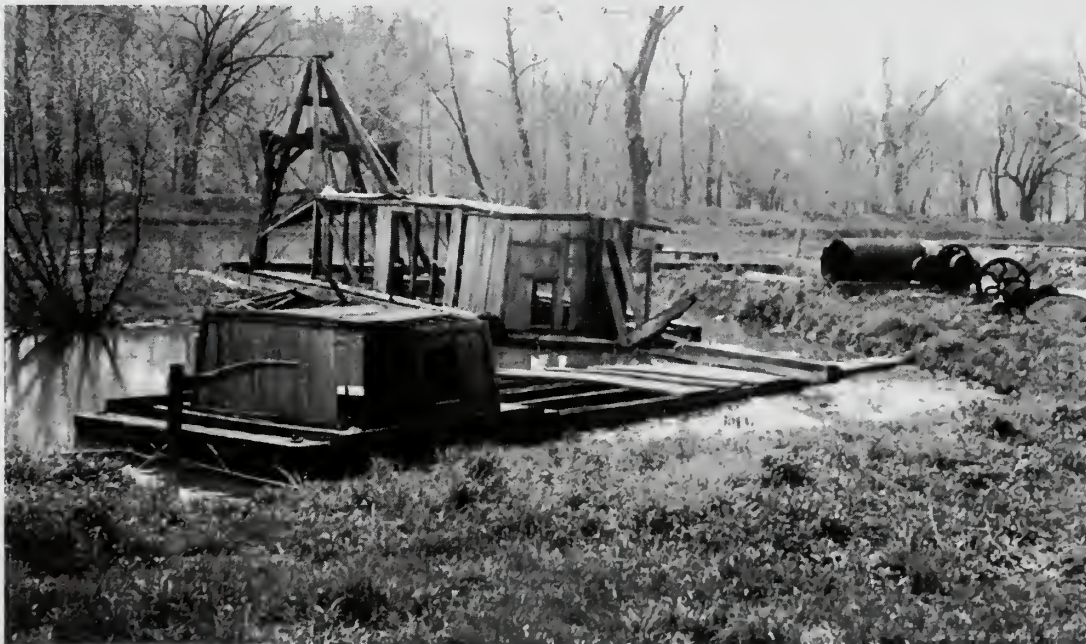
Photograph 64: The Canal “Graveyard”: An abandoned work barge and the dismantled dredge with boiler and some of the machinery lying on the shore. This is between Chain Bridge and Lock No. 5.
